Overview of the Mechanisms of Failure in Heat Treated Steel Components

Scott MacKenzie, Houghton International, Inc.

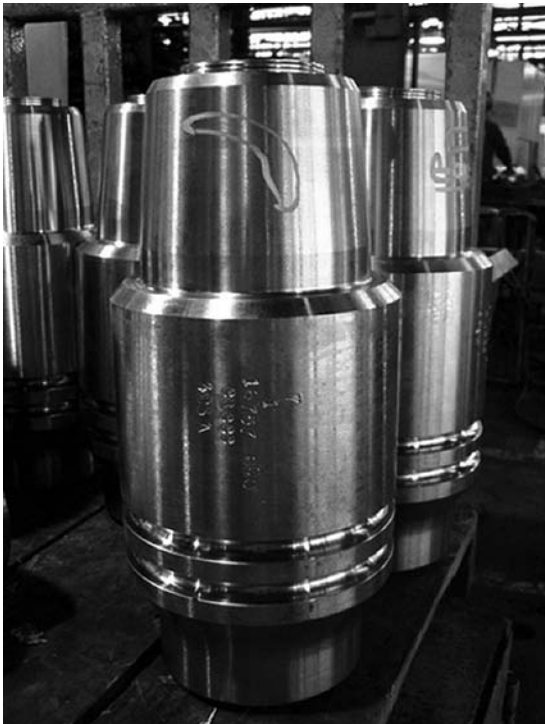
In one example (Fig. 1), a large roll was heat treated, and several large cracks were observed after inspection. This was originally attributed to quench cracking. On further examination, it was determined that a lap was present in the forging,

indicated by the presence of high-temperature oxides in the crack along the crack faces.

Fig. 1 A large roll was found to have cracks on the outer and inner surfaces of the forging. These cracks were found during final inspection. During examination of metallographic sections taken from the roll, high-temperature oxides were found on the crack faces, strongly suggesting forging laps.

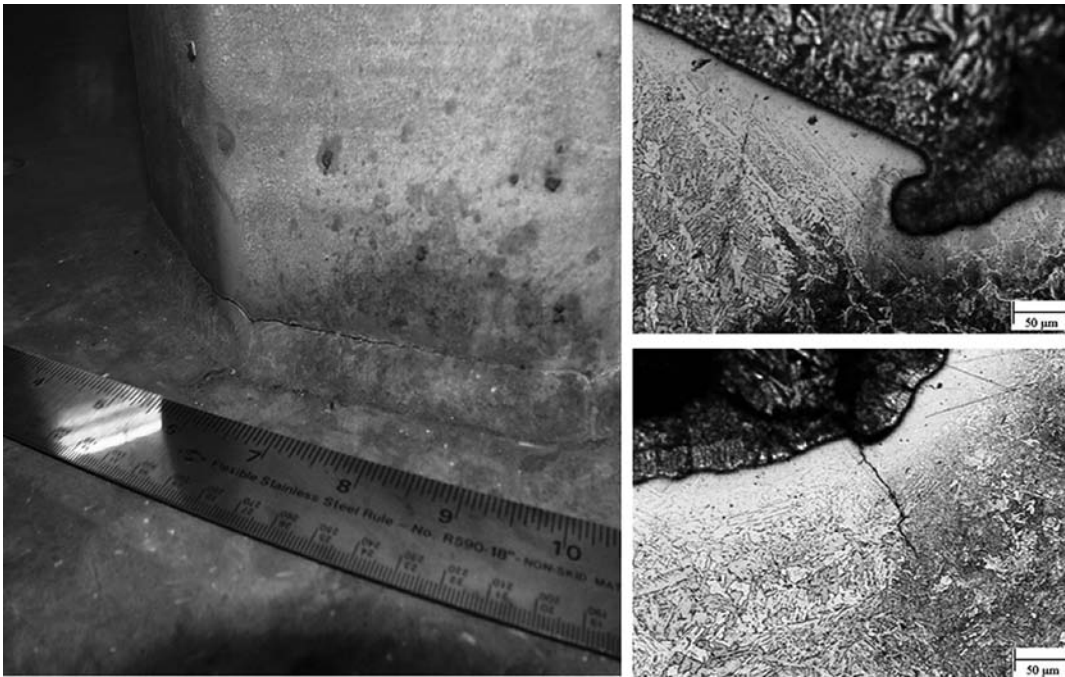
The mast arm failure shown in Fig. 3 (Ref 2) was the result of weld bead undercutting and poor weldment design. Fatigue cracking initiated at the site of the weld toe undercut. This location was a highly stressed area and the location of a large mechanical stress-concentration factor because of the weld toe undercut. Typical

Fig. 3 Failure of a mast arm due to fatigue that initiated at a weld toe undercut. Source: Ref 2

causes of undercutting include excessive weld current.

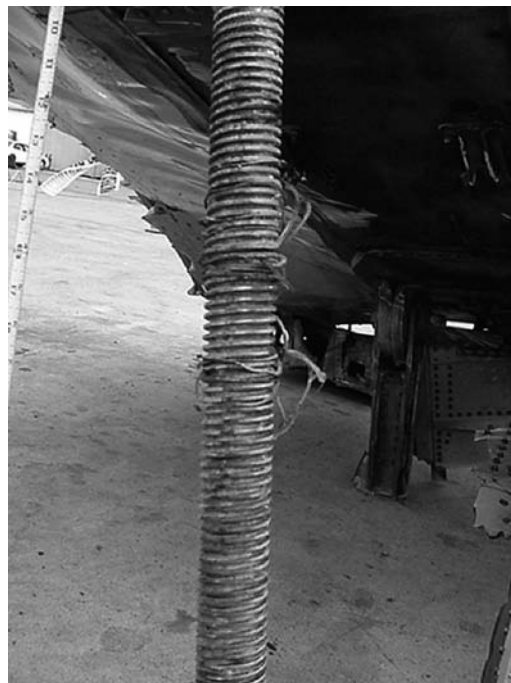
Fig. 4 The probable cause of this accident was a loss of airplane pitch control resulting from the in-flight failure of the acme nut threads on the horizontal stabilizer trim system jackscrew assembly. The thread failure was caused by excessive wear resulting from insufficient lubrication of the jackscrew assembly. Source: Ref 3

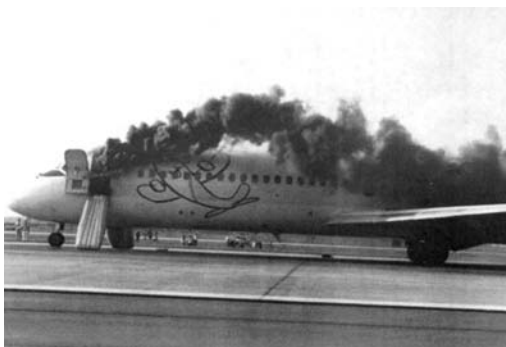
Fig. 5 The probable cause of this accident was the failure of maintenance and inspection personnel to perform a proper inspection of a seventh-stage high compressor disk, thus allowing the detectable crack to grow to a length at which the disk ruptured under normal operating conditions, propelling engine fragments into the fuselage. The fragments severed the right engine main fuel line, which resulted in a fire that rapidly engulfed the cabin area. Source: Ref 4

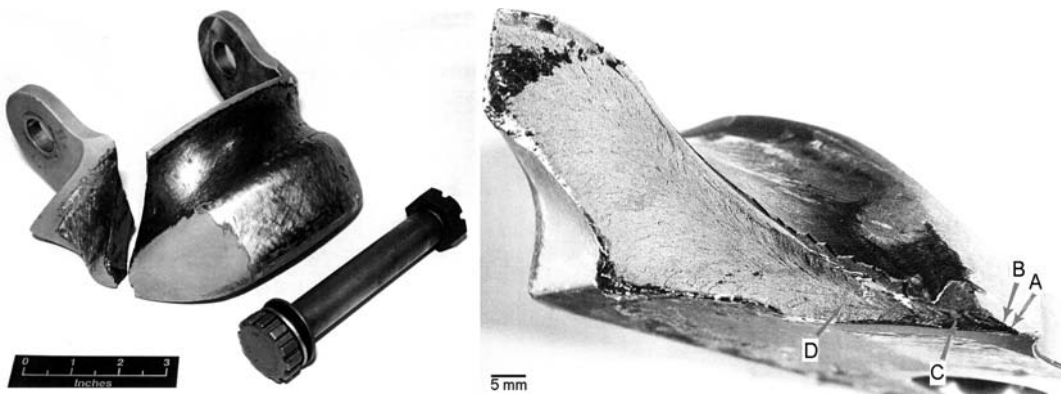
Fig. 19 Arresting gear hook-point, manufactured from AISI 4330V, that failed during landing. Failure occurred at the inner fillet radius of the right-hand lug

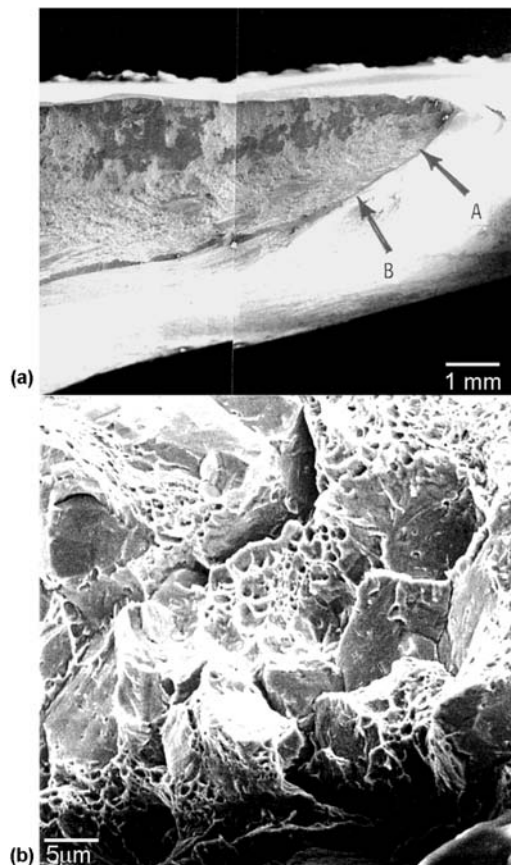
Fig. 20 SEM fractographs showing (a) location of origin at the inner fillet radius and (b) quasi-cleavage evident on the fracture surface

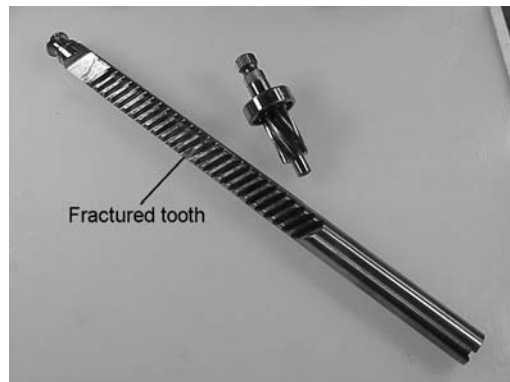
Fig. 22 As-received pinion gear that failed in service

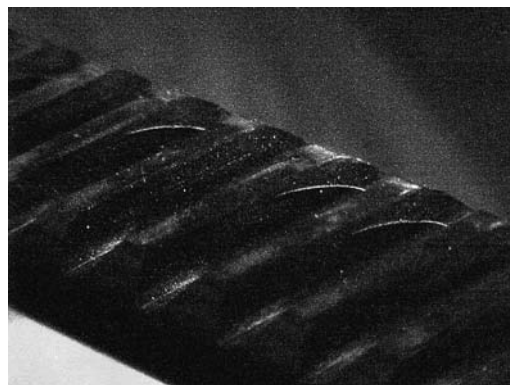
Fig. 23 Magnetic particle inspection of the failed pinion gear showed arc-shaped cracks on the gear tooth faces.

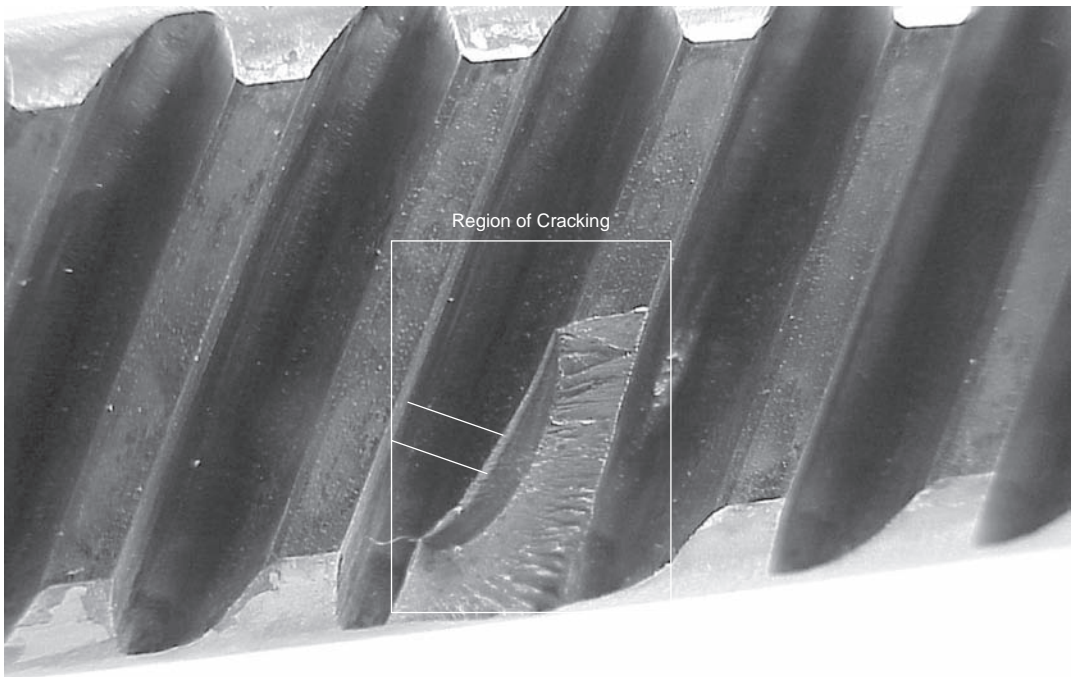
Fig. 24 Overall view of the cracked pinion showing the location of the fracture and the presence of a discolored region

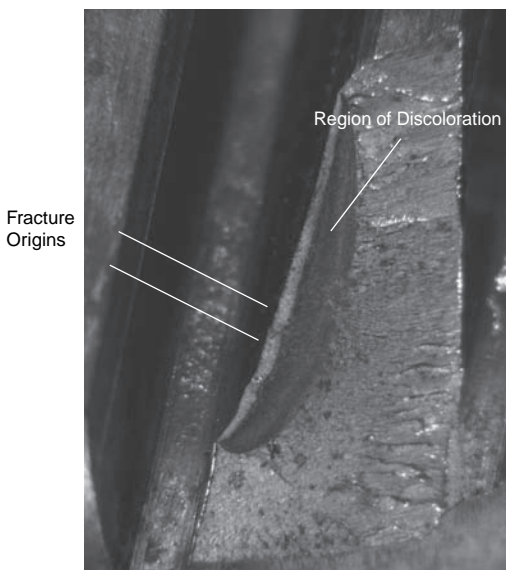
Fig. 25 Closeup of the fracture region showing the discolored region. The color of the oxidation indicated that the crack occurred after quenching and during the tempering operation.

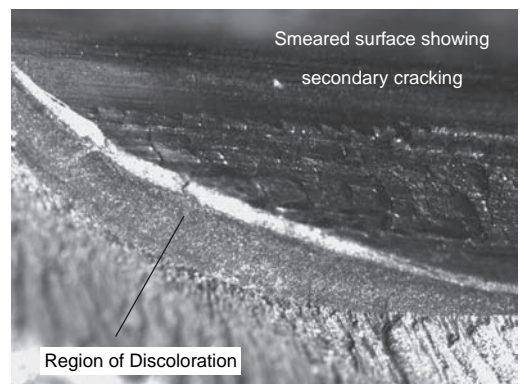
Fig. 26 Rough machining at the surface of the tooth showing smearing and tearing of the machined surface. This is suggestive of abusive machining, due to dull cutting tools, inadequate coolant, or excessive speeds and feeds.

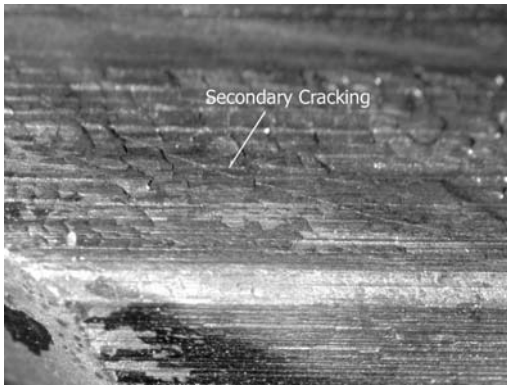
Fig. 27 Secondary cracking evident at regions of abusive machining

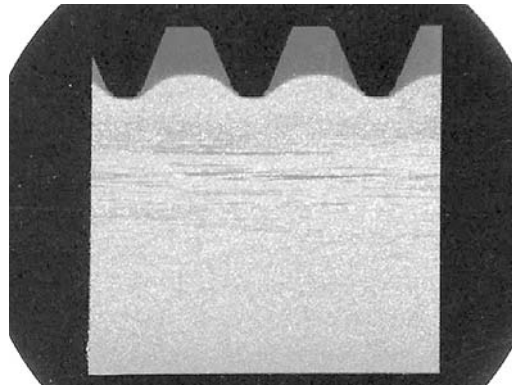
Fig. 28 Metallographic specimen of the pinion showing inadequate case at the root of the tooth. Etched in 0.5% nital

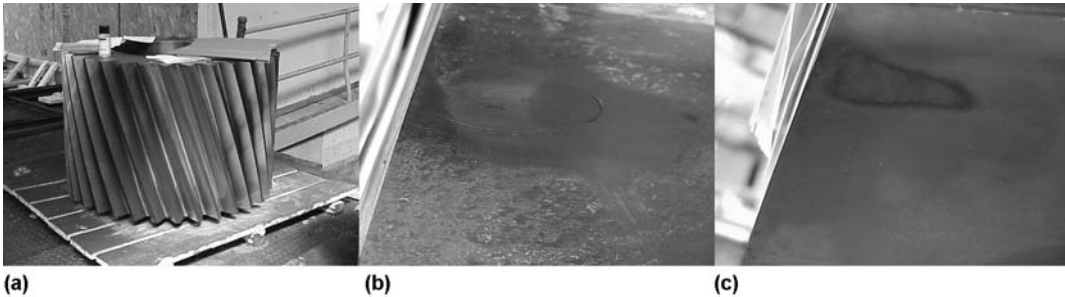
Fig. 29 Large gear that showed evidence of cracking. (a) As-received gear. (b) Crack evident on gear face. (c) Region after temper etching showing evidence of abusive grinding

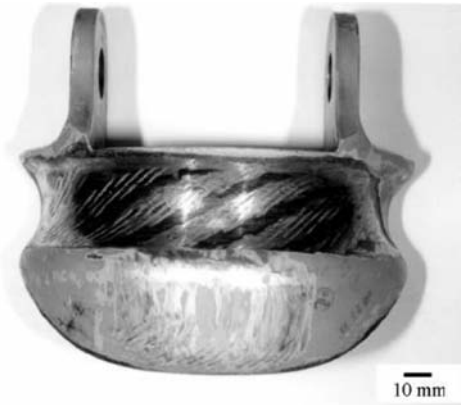
Fig. 30 Arresting gear hook-point showing vertical cracking in the cable groove and evidence of localized heating (from the temper colors in the cable groove)

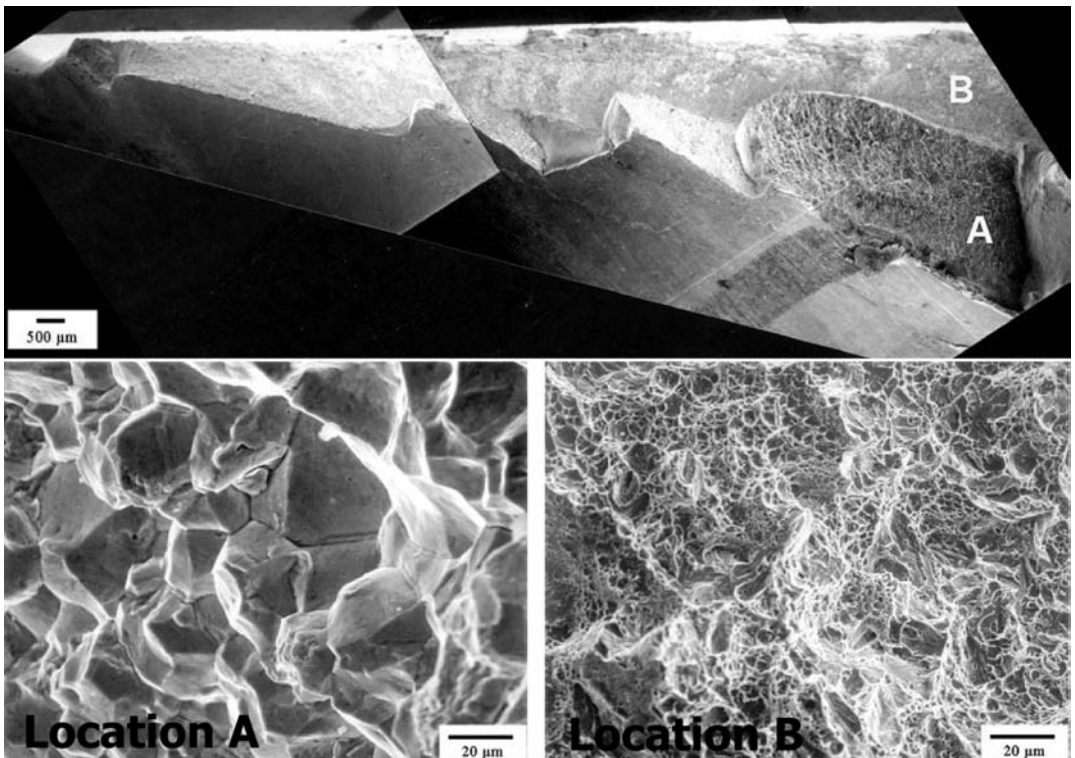
Fig. 31 SEM examination of the vertical cracking. "A" indicates the presence of intergranular cracking along prior-austenite grain boundaries. "B" indicates microvoid coalescence from the laboratory fracture during the exposure of the crack face.

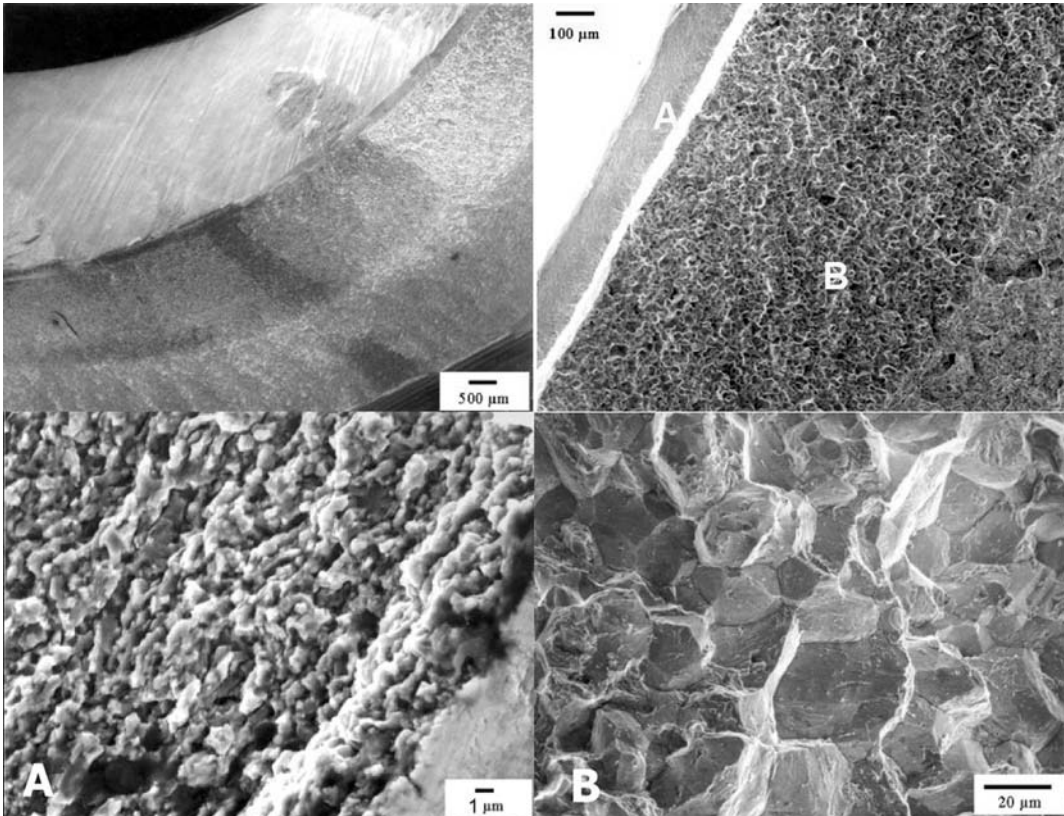
Fig. 32 Exposed crack face showing two distinct regions on the crack face. "A," region of incipient melting. "B," intergranular fracture

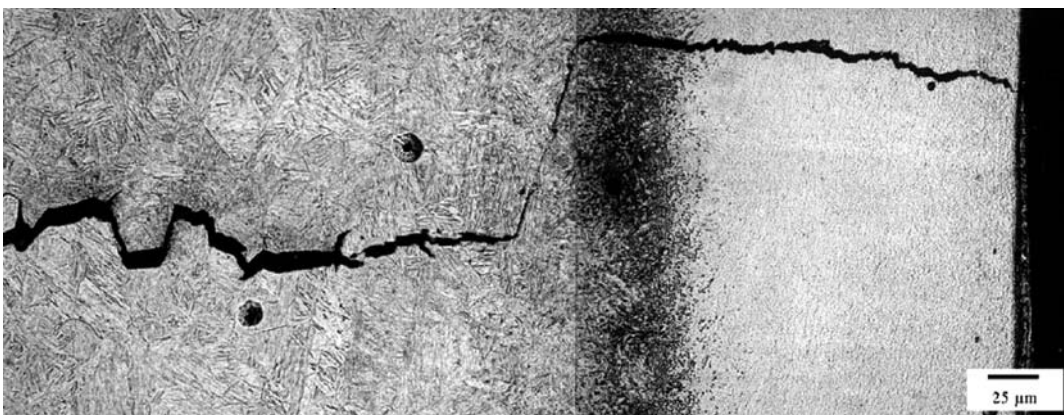
Fig. 33 Metallographic section through the vertical crack showing (from right to left) a lightly etching region of fine-grained untempered martensite, a transition region of overtempered martensite, and a region of nominally tempered martensite. Hardness in the untempered martensite was KHN 620. The transition region showed a hardness of 390 KHN, and the nominal core hardness was KHN 460

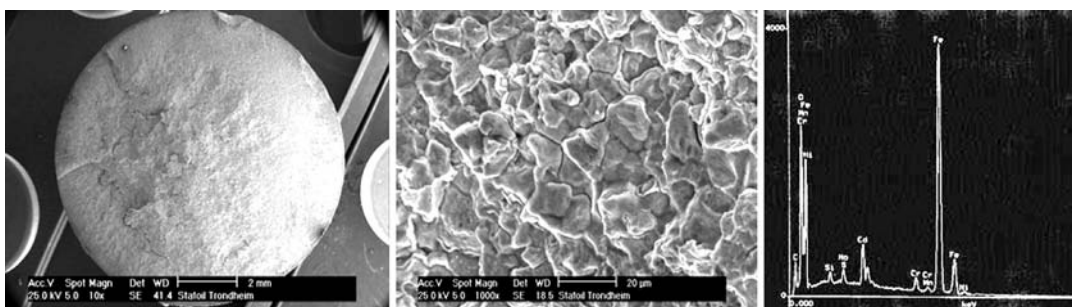
Fig. 36 Liquid metal embrittlement of a low-alloy bolt plated with cadmium that failed during service. Cadmium was found to have penetrated at the grain boundaries due to service above 230 °C. (a) Overall fracture surface. (b) SEM examination of fracture showing intergranular fracture. (c) X-ray diffraction spectrum at grain boundaries showing cadmium penetration

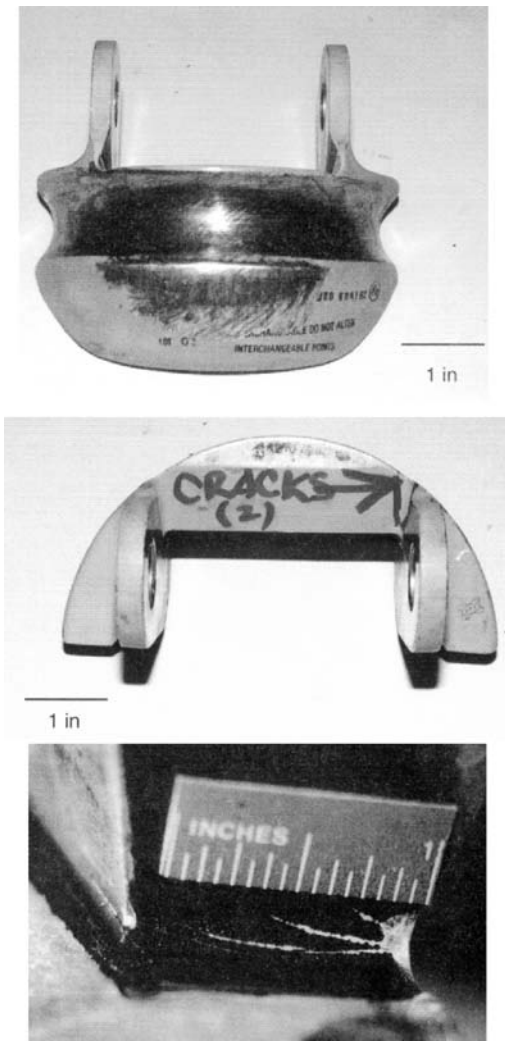
Fig. 37 AISI 4330V cadmium-plated hook-point used to arrest landings of naval aircraft. Overall view of the part, showing location of cracks observed using nondestructive testing

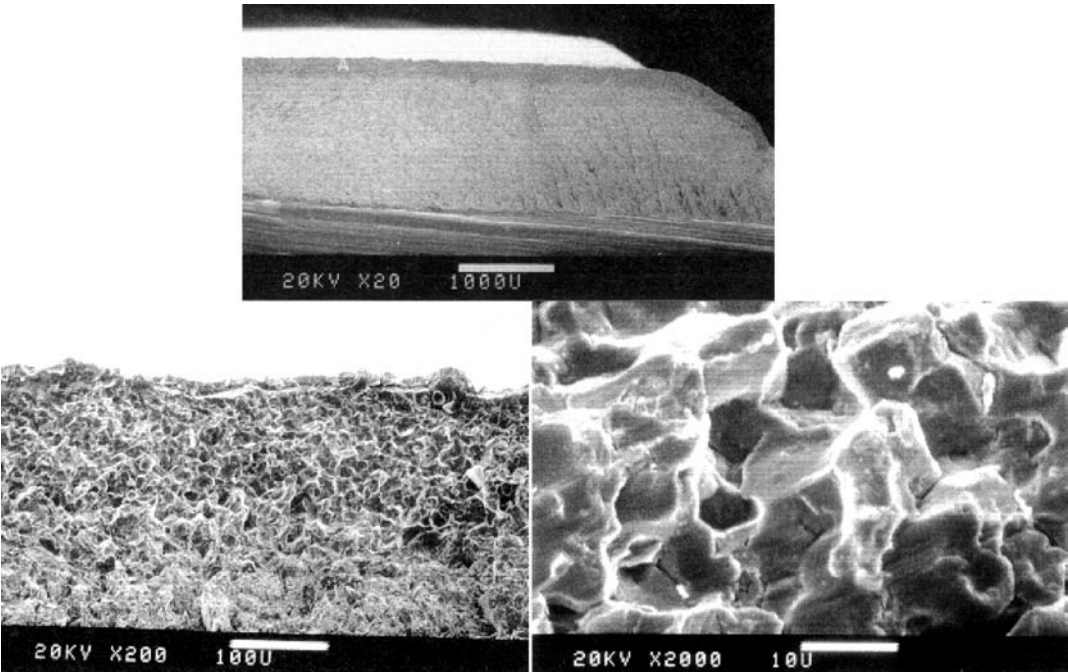
Fig. 38 SEM examination of the hook-point showing a narrow region of intergranular fracture along prior-austenite grain boundaries

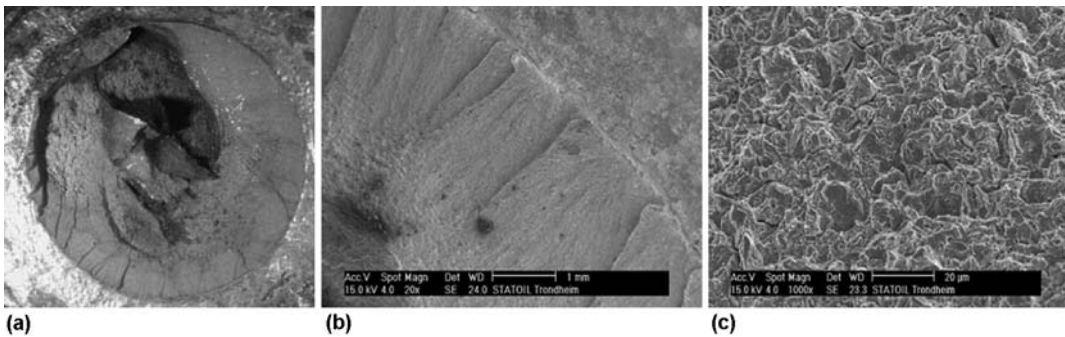
Fig. 40 Hydrogen embrittlement failure of an ISO 10.9 low-alloy steel bolt grade. (a) As-received bolt. (b) Multiple initiation sites with secondary cracks evident. (c) Intergranular fracture along prior-austenite grain boundaries

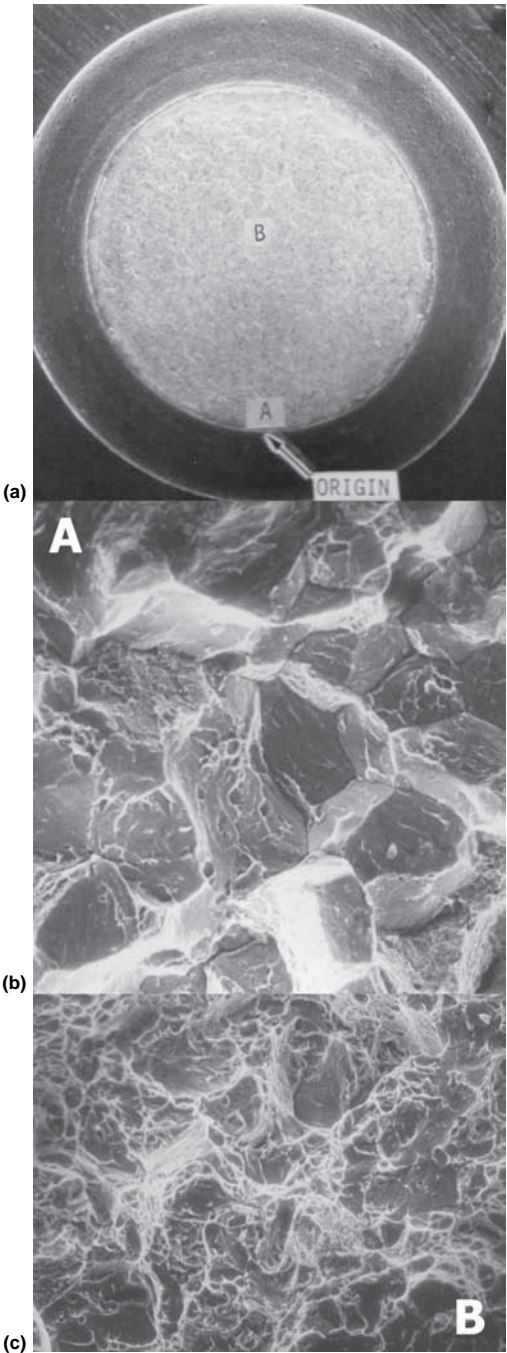
Fig. 42 Overall view of the fracture surface, showing location and results of SEM examinations. (a) Overall fracture surface and location of origin. (b) Intergranular fracture at the origin of cracking (location A). Original magnification: 1000 × . (c) Microvoid coalescence at location B

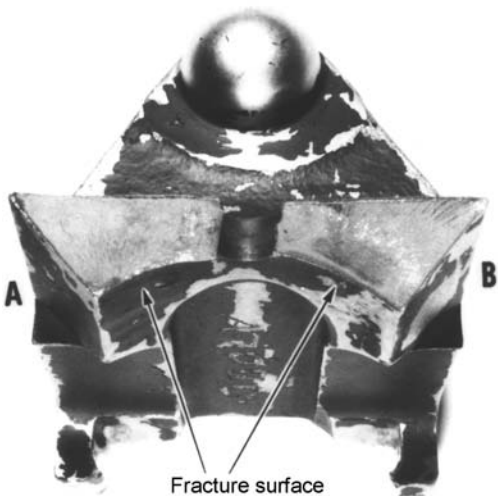
Fig. 43 As-received jack pad showing the locations of the two distinct origins on the inside bore of the hole for a pressed-in pin

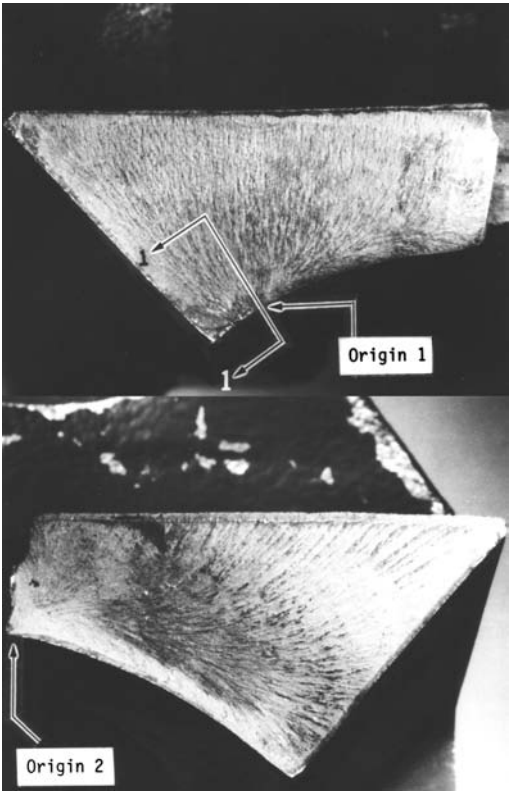
Fig. 44 Fracture surfaces of the jack pad showing location of the origins. Original magnification: 2 ×

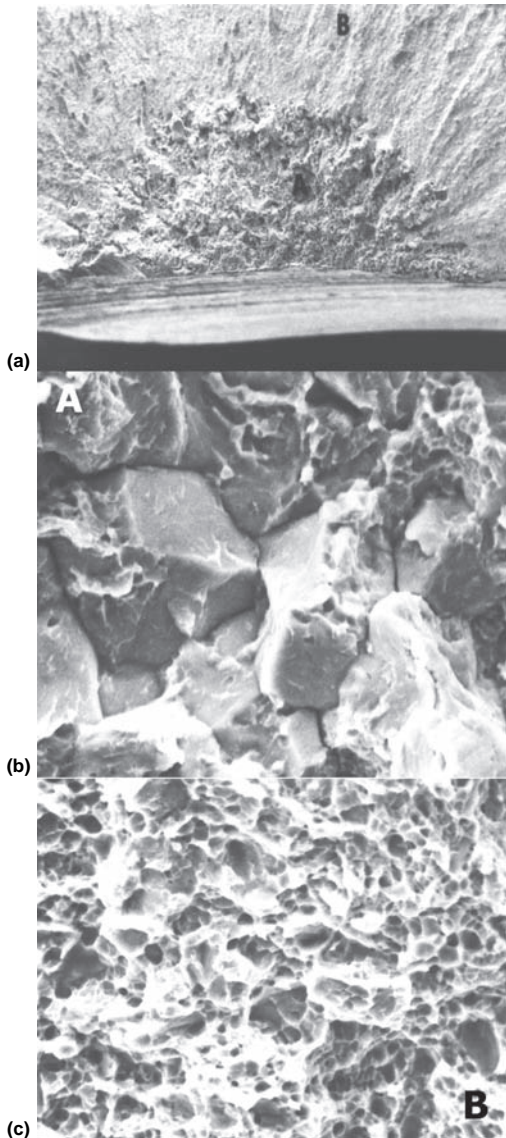
Fig. 45 SEM examination of origin 1. (a) Location of the fracture origin. Original magnification: 20 \times . (b) Location A showing a region of intergranular fracture along prior-austenite grain boundaries. Original magnification: 1000 \times . (c) Location B, at a distance away from origin 1, showing microvoid coalescence. Original magnification: 2000 \times

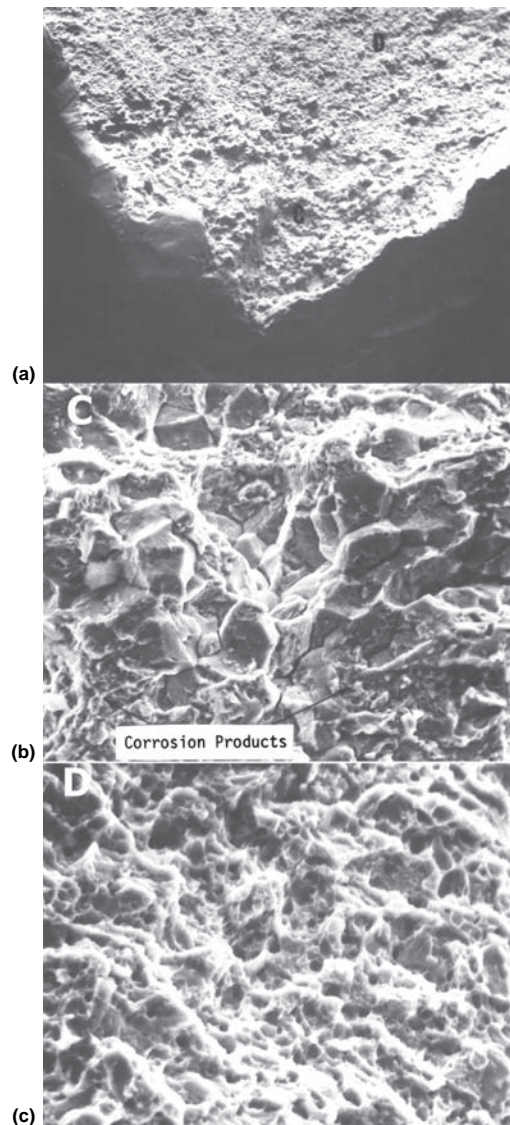
Fig. 46 SEM examination of origin 2. (a) Location of the fracture origin. Original magnification: 100 \times . (b) Location C showing a region of intergranular fracture along prior-austenite grain boundaries. Original magnification: 1000 \times . (c) Location D, at a distance away from origin 2, showing microvoid coalescence. Original magnification: 2000 \times

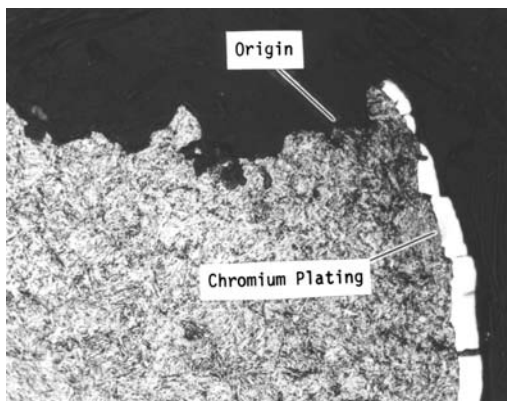
Fig. 47 Micrograph showing quenched and tempered martensite, typical of 300M heat treated to HRC 54 to 55. Note that the chromium plating is intact.

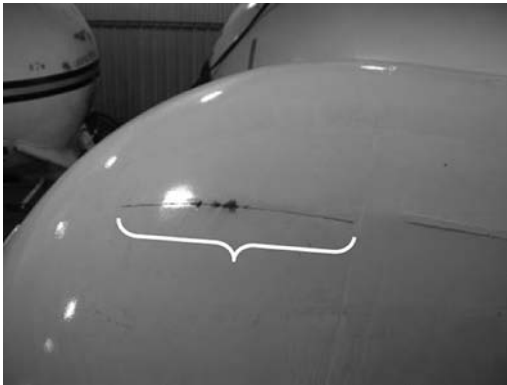
Fig. 50 Through-the-wall crack on accident tanker

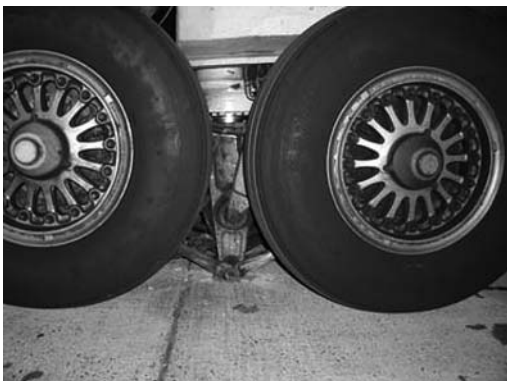
Fig. 51 Boeing 757-2008 truck beam failure occurring on Icelandic Air, aircraft registration TF-FIJ.

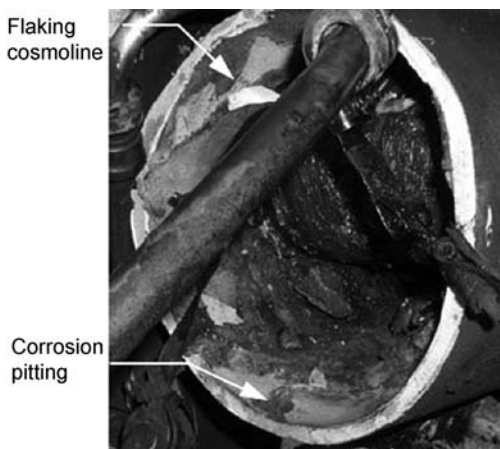
Fig. 53 Fracture surface of Boeing 757 main landing gear truck beam on Icelandic Air aircraft TF-FJ

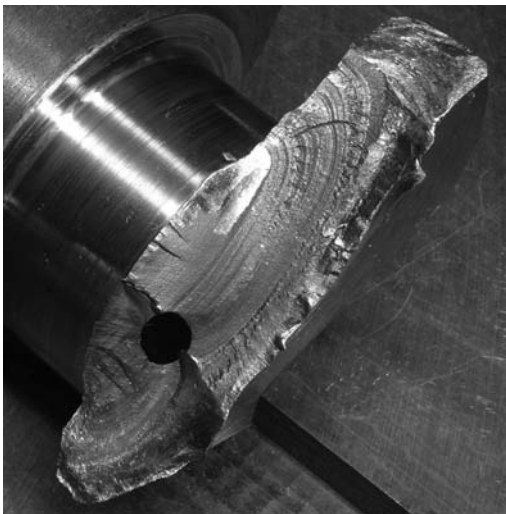
Fig. 56 Actual fatigue failure of a crankshaft showing characteristic beach marks. Fatigue initiated at the radius of the journal and exhibits classic bending fatigue.

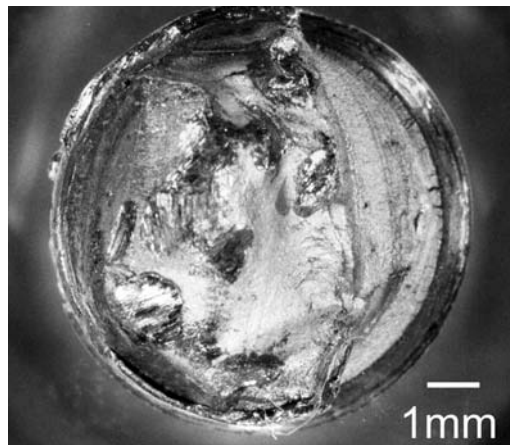
Fig. 57 Fatigue failure of a fastener, with initiation of fatigue occurring at the threads

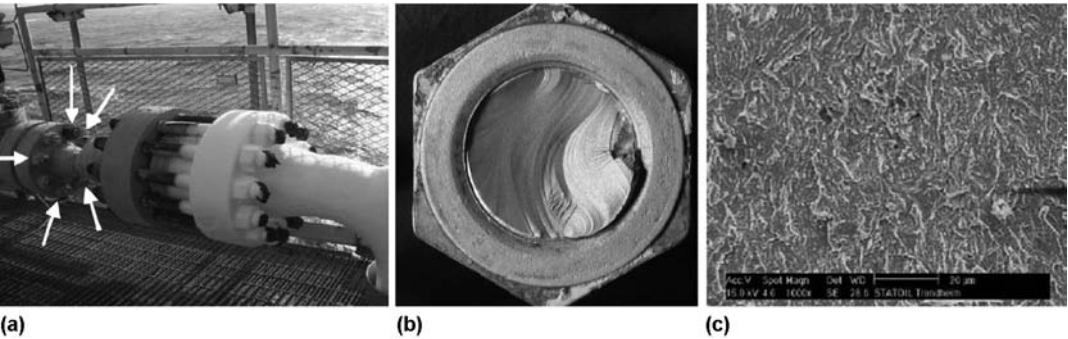
Fig. 64 ASTM B7 low-alloy steel bolt grade. Fracture initiated along threads, with typical and pronounced beach marks (i.e., cyclic fracture propagation) and transgranular fracture mode. (a) Location of bolts in pump coupling. (b) Beach marks showing asymmetrical bending with initiation at high stress-concentration factor at bolt threads. (c) Transgranular fracture morphology

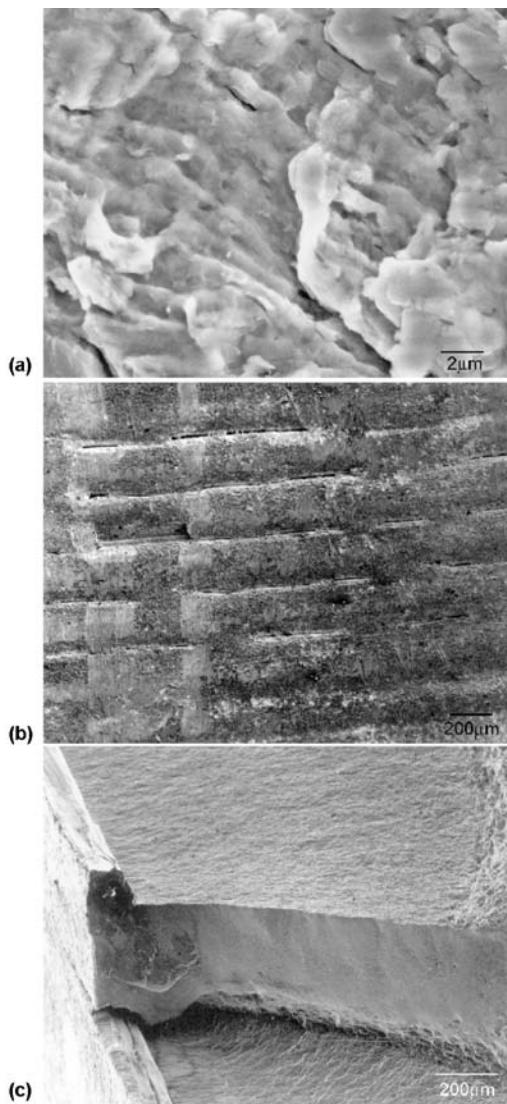
Fig. 67 SEM examination of the fracture surface. (a) Fatigue striations emanating from the fracture origin. (b) Machining marks found on the surface of the inner bore. (c) Well-defined layer showing fatigue emanating from the damaged material at the surface of the inner bore

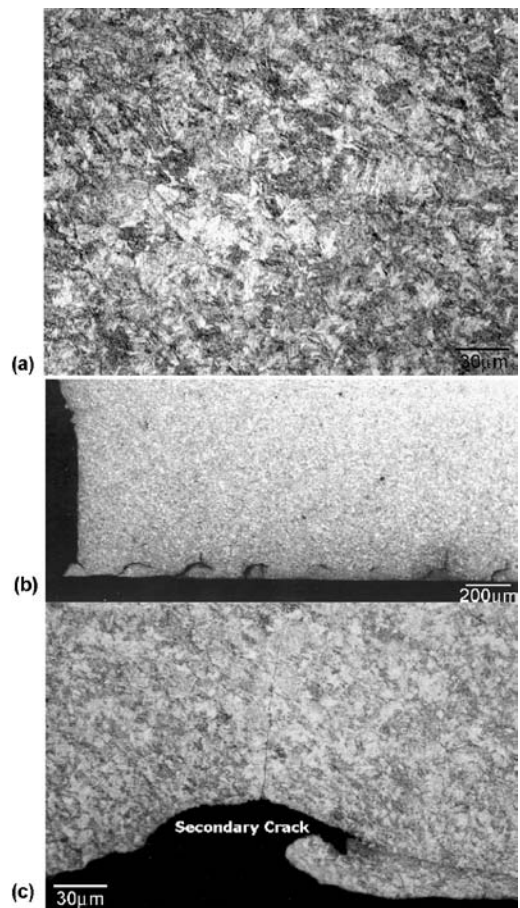
Fig. 68 Metallography of the arresting hook shank. (a) Typical quenched and tempered martensite found. This is typical for the hardness of the arresting hook shank. (b) Pulled material at 4.3 mm (0.17 in.) intervals along the inner bore of the arresting hook shank. Origin is to the left. (c) Secondary cracking observed at the location of pulled material
