THE STRUCTURAL STEEL OF THE WORLD TRADE CENTER TOWERS

Frank W. Gayle,*
Stephen W. Banovic,* Tim Foecke,
Richard J. Fields, William E. Luecke
*Metallurgy Division,
National Institute of Standards and Technology
Gaithersburg, Maryland*

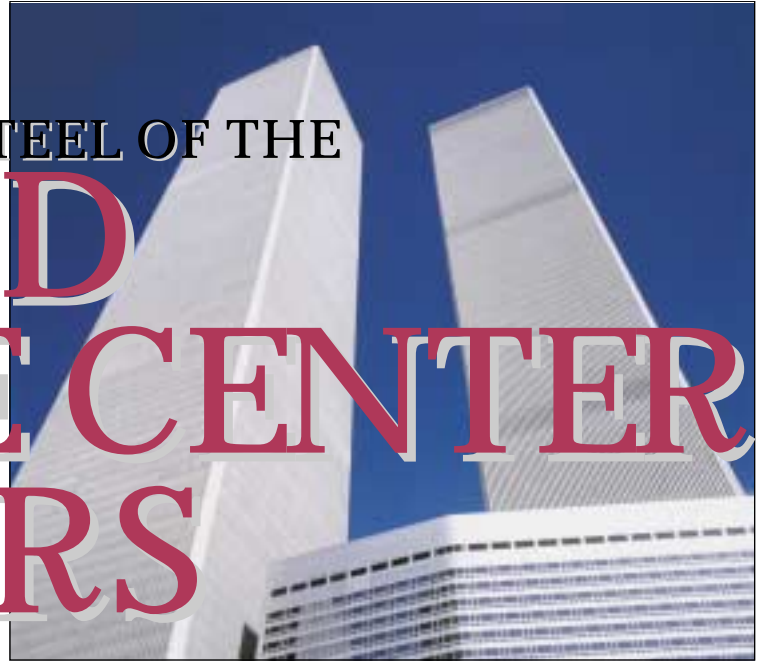
Fig. 1 — The World Trade Center in New York City before the terrorist attack. Image courtesy Port Authority of New York and New Jersey.

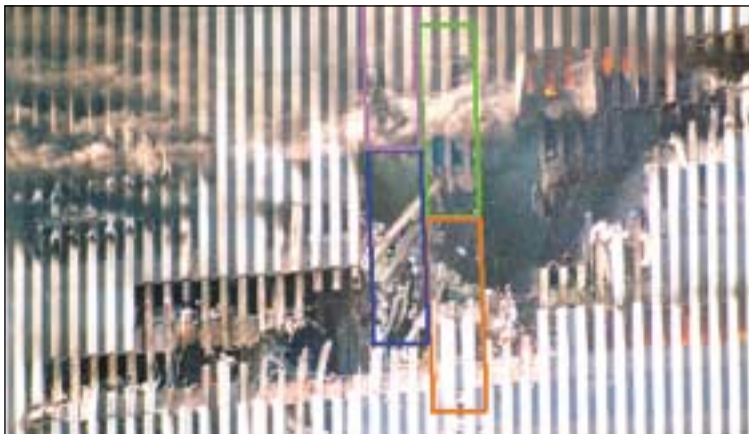
Fig. 3 — Enhanced photographs used to determine pre-collapse damage to the perimeter panels of WTC 1. Colored boxes indicate location of recovered panels that were damaged as a result of aircraft impact.

Extensive image processing was used on photographs received from news organizations and the public to determine pre-collapse damage to the perimeter panels. Figure 3 shows the impact image used to extract perimeter column failure mode information from WTC 1. Superimposed onto this figure is the outline of the aircraft (Fig. 4). Careful examination of such images has allowed the characterization of the types of column failures as indicated.
