Overview of the Mechanisms of Failure in Heat Treated Steel Components

Scott MacKenzie, Houghton International, Inc.

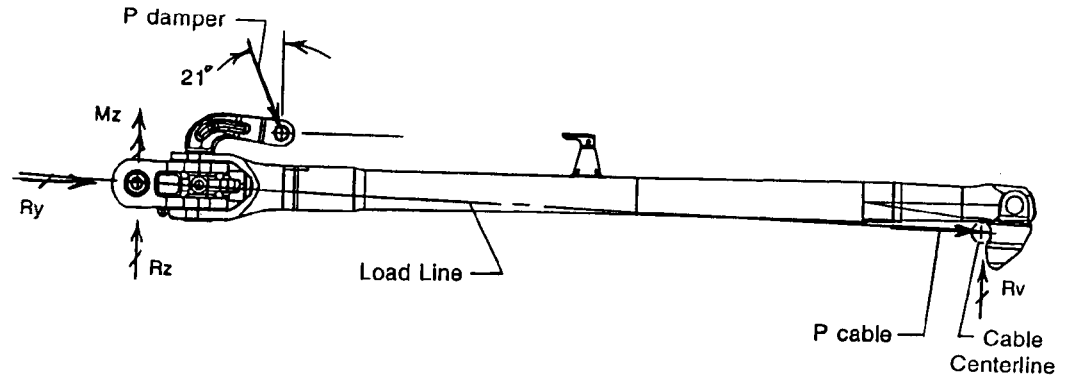
An example of a manufacturing effect on fatigue is the following example of an arresting gear hook shank (Fig. 65) used to slow down aircraft when landing on aircraft carriers. In this example, the hook failed after 1361 simulated arrestments, which was below the lifetime of 2250 arrestments. The part is designed to last

two lifetimes, or 4500 arrestments, without cracking (0.25 mm, or 0.010 in. detectible flaw). The arresting shank was fatigue tested in a fixture, with hydraulic cylinders providing loads at the vertical damper and hook-point cable groove. The maximum applied load was 90 mg (200,000 lb). A schematic of the arresting hook shank is shown in Fig. 65.

Examination of the fracture surface showed that cracking initiated at the hook-point side, on the inner diameter, at a location approximately 26.5 cm (10.5 in.) aft of the uplock retainer. The fracture had characteristics of fatigue fracture, with multiple origins observed. Surface roughness measurements varied across the inner bore, from approximately 1 to 5 μm (40 to 180 $\mu\text{in.}$). The drawing requirement was 3 μm (125 $\mu\text{in.}$). Circumferential machining marks were found at the fracture origin (Fig. 66). SEM examination (Fig. 67) showed fatigue striations emanating away from the identified origin. Cracking was found to have initiated at circumferential machining marks. Machining marks were observed at 4.3 mm (0.17 in.) intervals. Many secondary cracks were observed at the machining marks. Fatigue was found to initiate subsurface to the inner bore, adjacent to the machining marks. A well-defined surface layer was observed. This layer had the appearance of mechanical working or damage. This observed layer followed the feeds and speeds of the injection drill. Metallography showed that the material was quenched and tempered martensite and was typical for this material heat treated to this hardness. At the

Fig. 65 Schematic of the failed arresting hook shank showing location of loads
